**NASHUA RIVER BASIN
HOLDEN, MASSACHUSETTS**

**KENDALL RESERVOIR DAM
MA 00622**

**PHASE I INSPECTION REPORT
NATIONAL DAM INSPECTION PROGRAM**

OCTOBER 1978

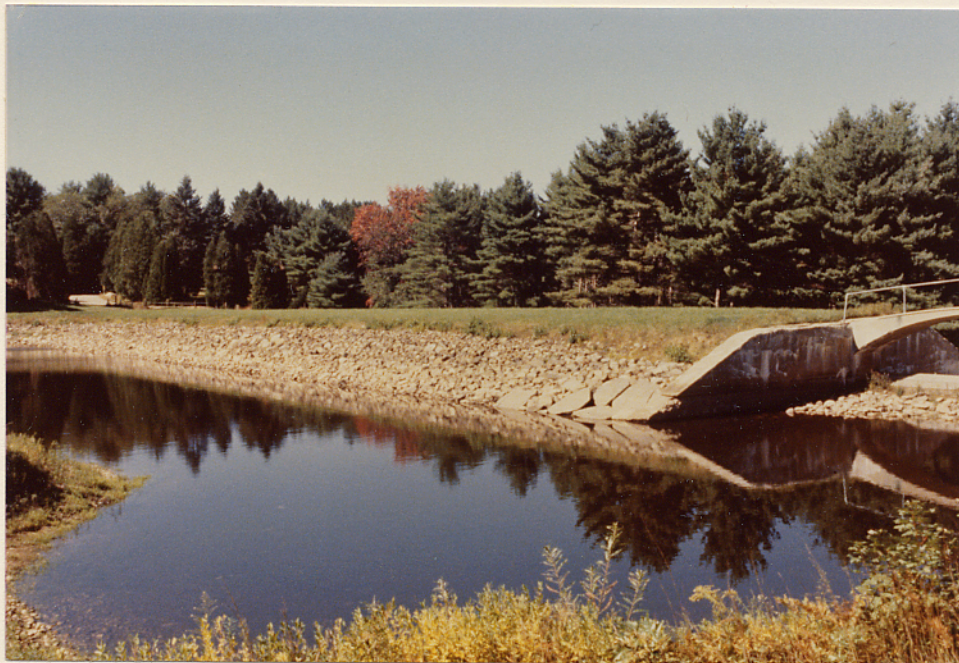
UPSTREAM FACE OF DAM, AND SPILLWAY

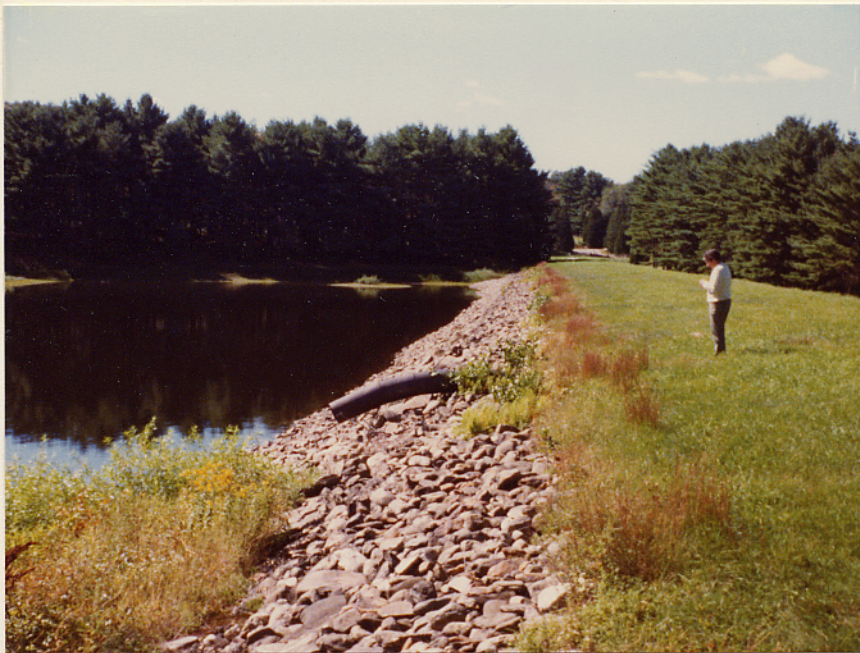
NO. 1 UPSTREAM SLOPE OF DAM

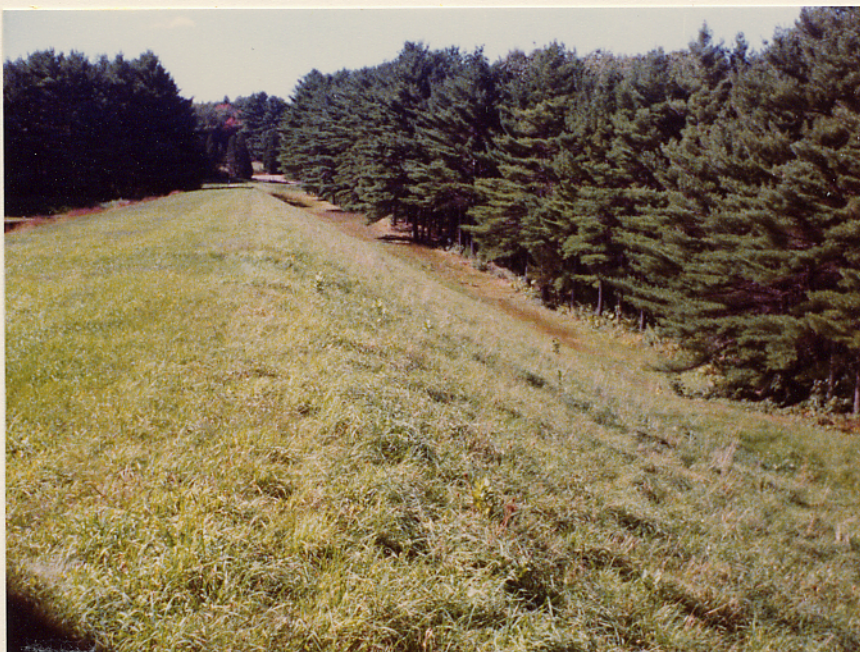
- b. Dam. The earthfill dam at the north end of the reservoir is in good condition. The major area of concern is the seepage about 55 feet beyond the downstream toe of the dam. This seepage occurs in the woods, in the vicinity of the buried concrete headwall of the low-level outlet. Slight settlement of the crest was noted along the alignment of the outlet pipe. A second area of slight seepage was noted at the downstream toe of the embankment, to the left of the spillway. In addition, a number of animal burrows were apparent on the crest and downstream slope of the dam. Otherwise the embankment is flat, straight, and free of trees and brush. The riprapped upstream slope of the dam is in very good condition. Generally, the embankment appears to be well-maintained by the Owner.

NO. 2 DOWNSTREAM SLOPE OF DAM

- 7.2 Recommendations. In view of the concerns over the continued performance of the dam it is recommended that the Owner employ a qualified consultant to investigate the seepage at the toe of the dam.

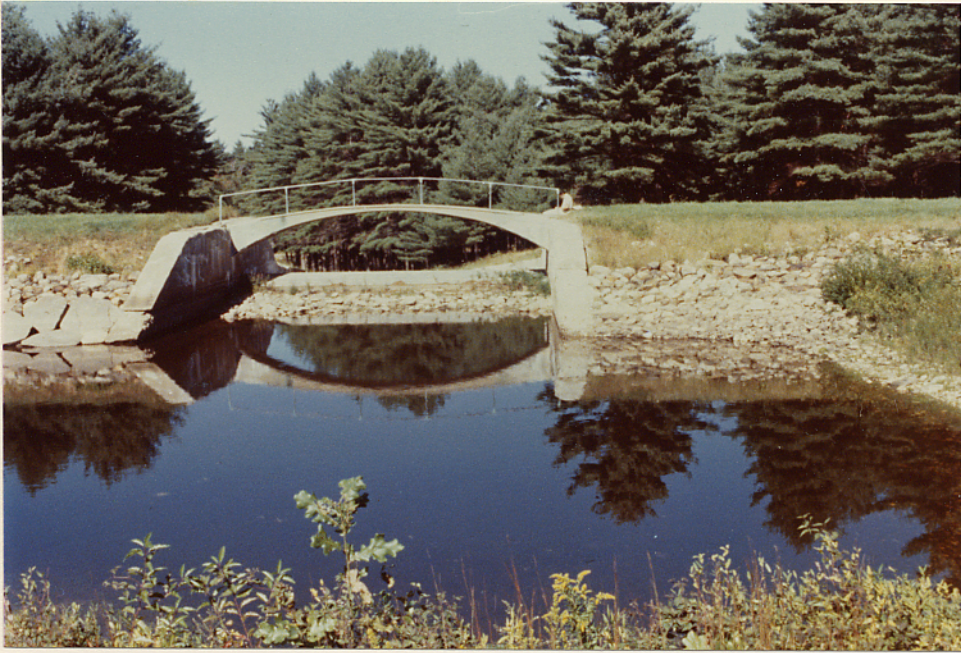
- c. Appurtenant Structures. The spillway at Kendall Dam is in poor condition due to deterioration of the concrete. The side walls, from the approach to the discharge channel, show severe spalling and efflorescence. The reinforcing is visible in many locations, and beginning to rust, and the crumbled concrete is accumulating on the floor of the spillway. Minor amounts of grass are growing in the construction joints on the concrete slab, and along the base of the side walls. The rest of the channel floor is in

b. Weir and Training Walls	flat concrete slab with concrete walls, concrete pedestrian bridge arches over spillway
General Condition of Concrete	weir - fair walls - very poor
Rust or Staining	slight, visible on reinforcing
Spalling	severe
Any Visible Reinforcing	yes, in numerous locations
Any Seepage or Efflorescence	severe efflorescence; no seepage
Drain Holes	none

NO. 3 UPSTREAM VIEW OF SPILLWAY

- (1) rebuild or repair the concrete sidewalls to the spillway, and resurface the floor of the channel
- (2) replace the "permanent" flashboards with collapsible flashboards designed to break away during periods of high flow or remove the flashboards,
- (3) remove the debris from the low-level outlet, and clear the trees away from the toe to expose the seepage area,
- (4) fill in the animal burrows on the crest and downstream slopes of both the dam and the dike,
- (5) all repairs and maintenance should be undertaken in accordance with all applicable State regulations,
- (6) institute a definite plan for surveillance and a warning system during periods of unusually heavy rains and/or runoff,
- (7) technical inspections of this dam should be conducted on a bi-annual basis.

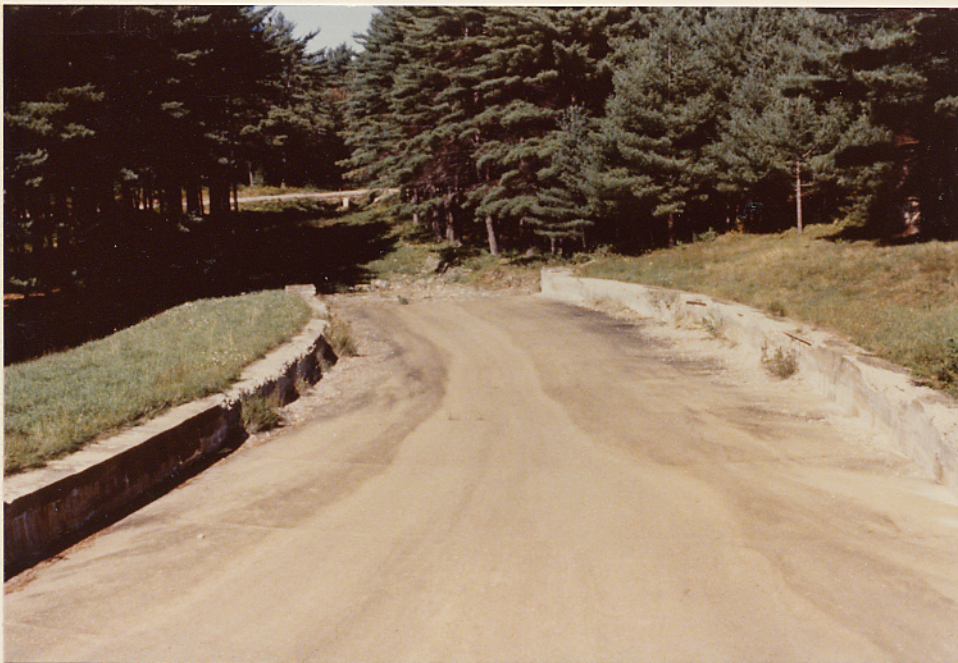
c. Discharge Channel	concrete channel changes to earth channel
General Condition	walls in very poor condition
Loose Rock Overhanging Channel	none
Trees Overhanging Channel	none
Floor of Channel	concrete slabs change to earth channel
Other Obstructions	none

NO. 4 DOWNSTREAM SPILLWAY CHANNEL

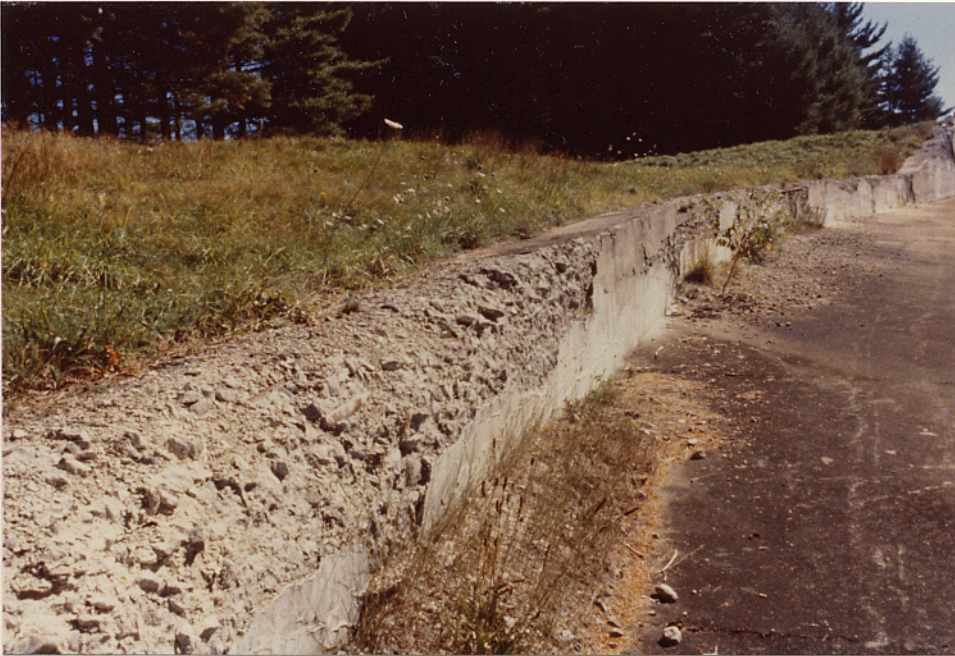
- c. Visual Observations. At the time of the inspection the water level in the reservoir was almost 2 feet below the crest of the spillway. The concrete on the spillway and particularly on the sidewalls is badly spalled. Although this condition is not particularly hazardous at this time, it should be corrected as continued deterioration could result in collapse of the spillway walls. Also, the low-level outlet at the dam was blocked with soil and debris. This should be cleared to allow the

**NO. 5 DETAIL OF DETERIORATION AND SPALLING OF
WALL OF SPILLWAY CHANNEL**

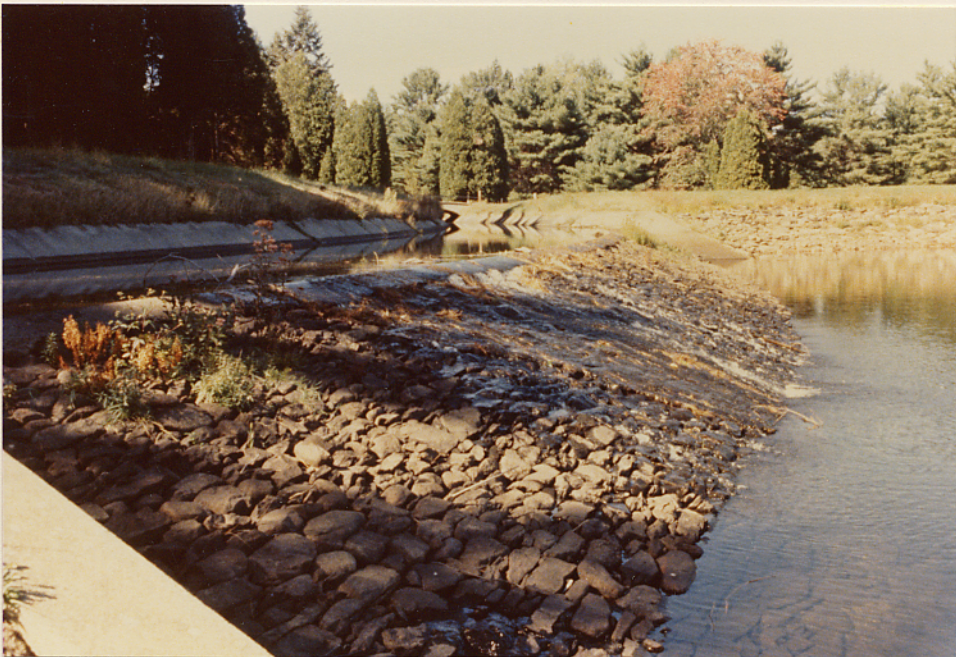
The side channel spillway at the right abutment of the dam discharges water from the Asnebumskit Canal. The stone cascade on this spillway is in good condition, with only a few weeds growing between the stones. The concrete lining of the canal is also in good condition.

**NO. 6 OUTLET FOR DIVERSION CANAL FROM
PINE HILL RESERVOIR**

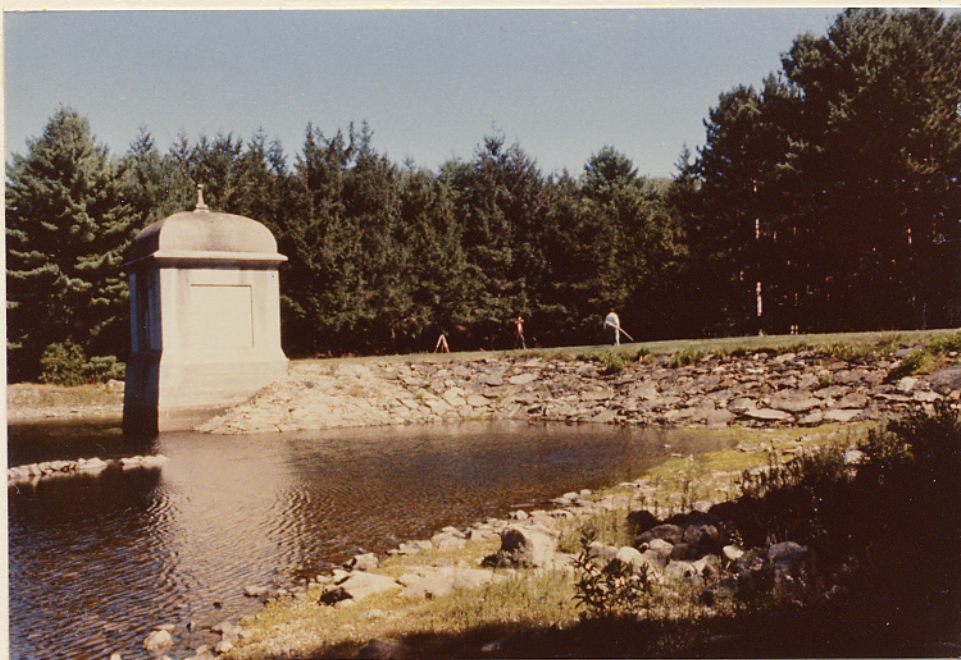
The dike and water supply outlet are located at the southern end of Kendall Reservoir. The earthfill dike ties into natural ground at both abutments. The crest is flat and clear of brush and trees. A concrete stairway is located on the downstream slope. The riprap on the upstream slope is in good condition, and supports only small amounts of vegetation.

NO. 7 DIKE AND GATE HOUSE AT SOUTH END OF RESERVOIR

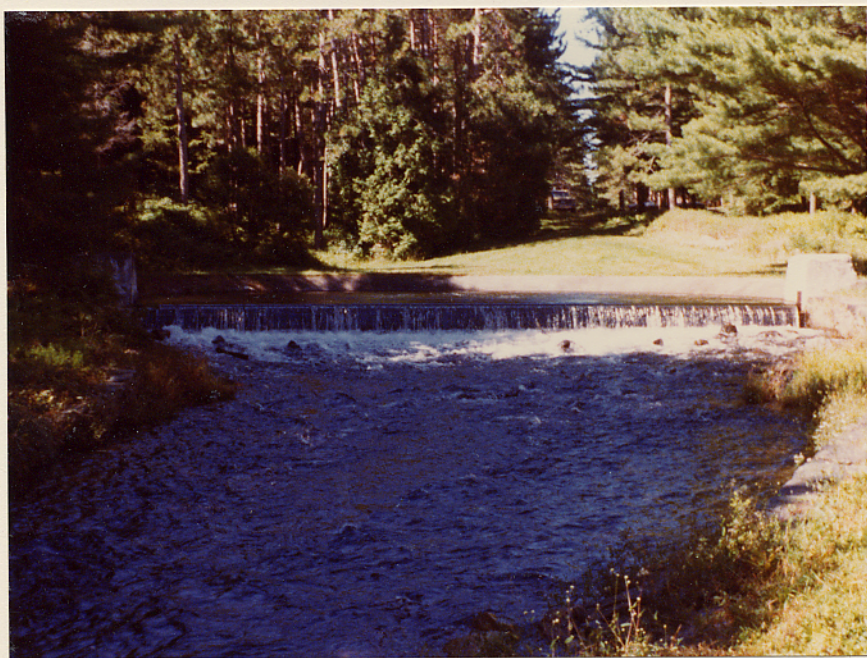
NO. 8 DISTRIBUTION POOL DOWNSTREAM OF DIKE
